This report contains general discussions of the storms and floods of April–June 1957 and detailed stream flow records of the flood-affected areas for the flood period. Sections on special hydraulic and hydrologic studies include flood-routing and flood-frequency studies for parts of the Brazos and the Colorado River basins in Texas, and rainfall-runoff studies on selected river basins in Texas.

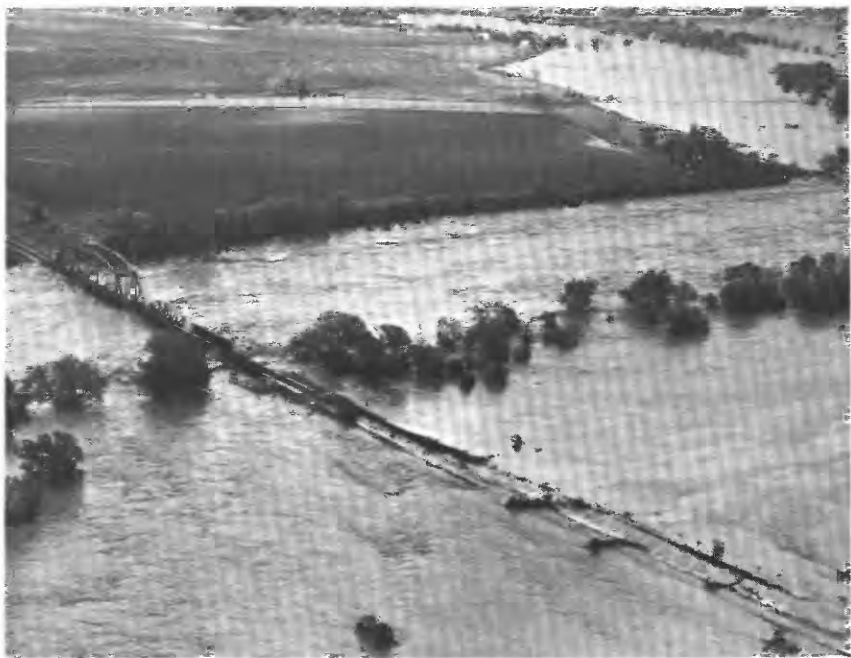
FIGURE 2.—View of San Gabriel River at Georgetown, Tex., near crest of flood, April 24, 1957, showing damage to Missouri-Kansas-Texas Railroad bridge. Photograph by United Press.

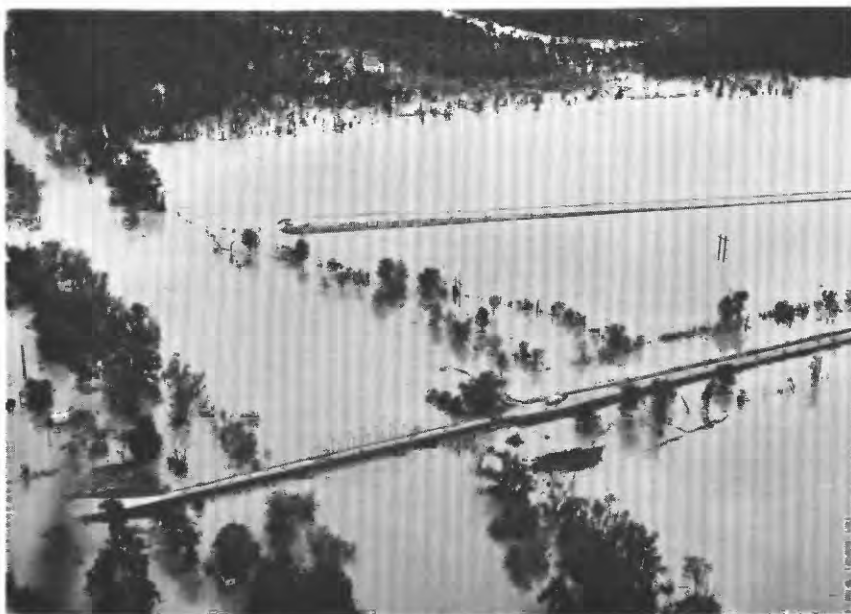
FIGURE 3.—View of floodwaters of the Trinity River spread over bottomlands near Crockett, Tex., April 25, 1957. Photograph by U.S. Army Corps of Engineers.

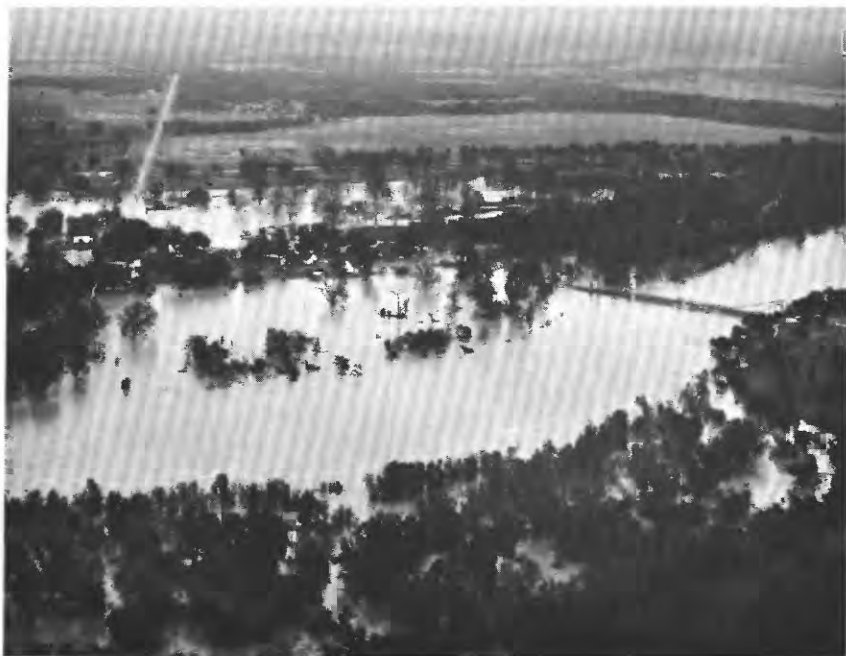
FIGURE 4.—View of floodwaters of the Brazos River spread over bottomlands at Dennis, Tex., May 1, 1957. Photograph by U.S. Army Corps of Engineers.

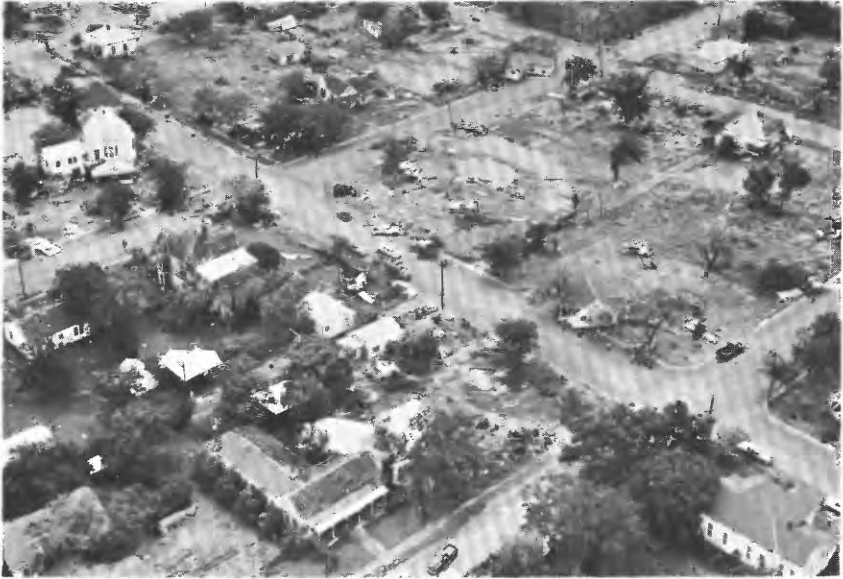
FIGURE 6.—Aerial view of flood damage in residential area of Lampasas, Tex., flood of May 12, 1957. Photograph by United Press.

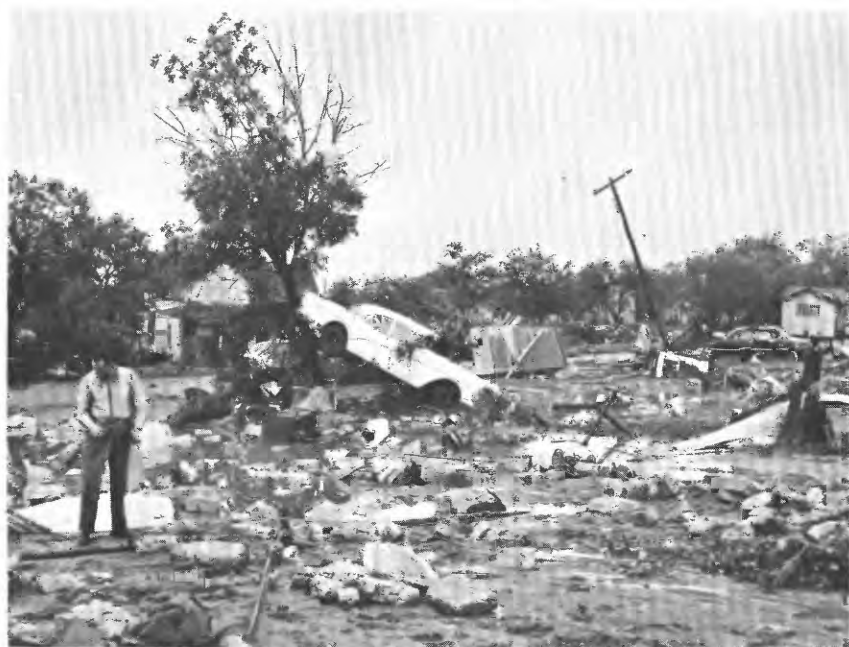
FIGURE 7.—View of flood damage in residential area of Lampasas, Tex., flood of May 12, 1957. Photograph by Texas Department of Public Safety.
